Manhole Inspection Summary

Manhole # S45C2_028MH

Insp Date: **12/27/07 1:06 PM**

Location Address: **3907 Pennington Ave**

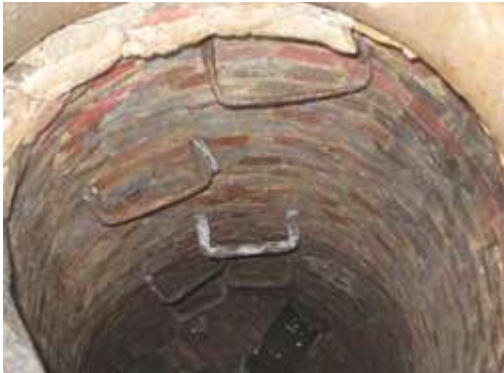
Steps

Count: **6** Missing: **0** ☒ Corroded

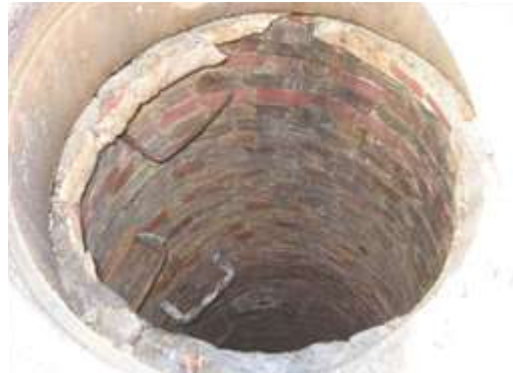
Defect 1

Infiltration: ☐ None ☐ Joint ☒ Cracks ☒ Mortar ☐ Roots ☐ Wall

Cracks/Mortar

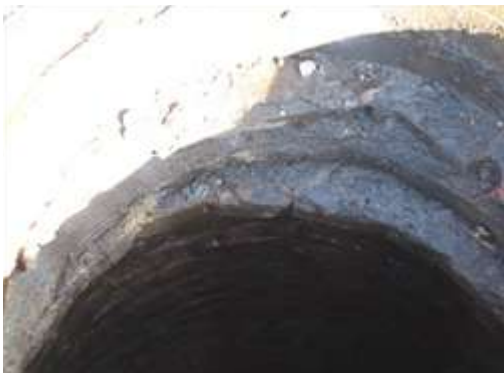
Defect 2

Offset: **6** (in.)

Frame offset

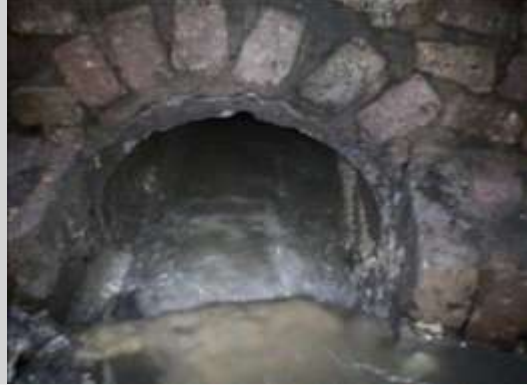
12 O'Clock Outflow

12 in. Circular Gravity Sewer
Pipe Out @ 12 O'Clock

Pipe Height: **16.8** (in.) Rod and Bar (Angled)
Pipe Material: **Clay** ☐ Pipe Lined
Invert Depth: **12.98** (ft.) Flow Characteristics: **Fast**
Deposits: ☒ None ☐ Mud ☐ Sludge ☐ Debris ☐ Grease
Silt Depth: (in.) Deposits Extent:
Infiltration: **None** Pipe Seal Cond: **Sound**

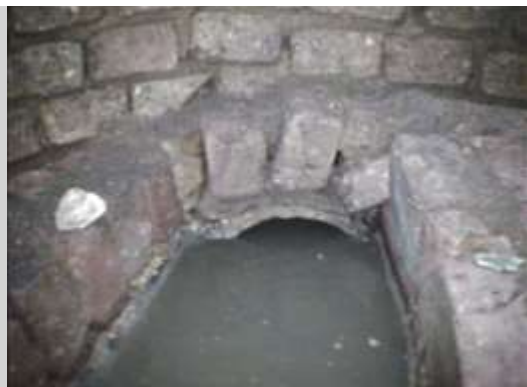
3 O'Clock Inflow

6 in. Circular Service Sewer
Pipe In @ 3 O'Clock

Pipe Height: **7.2** (in.) Rod and Bar (Angled)
Pipe Material: **Clay** ☐ Pipe Lined
Invert Depth: **12.59** (ft.) Flow Characteristics: **Slow**
Deposits: ☒ None ☐ Mud ☐ Sludge ☐ Debris ☐ Grease
Silt Depth: (in.) Deposits Extent:
Infiltration: **None** Pipe Seal Cond: **Sound**

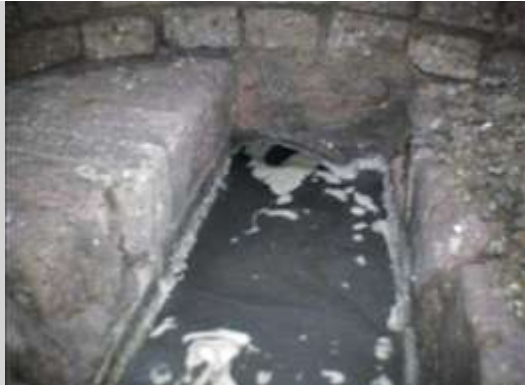
6 O'Clock Inflow

8 in. Circular Gravity Sewer

Pipe In @ 6 O'Clock

Pipe Height: **10.8** (in.) Rod and Bar (Angled)

Infiltration: **None** Pipe Seal Cond: **Sound**

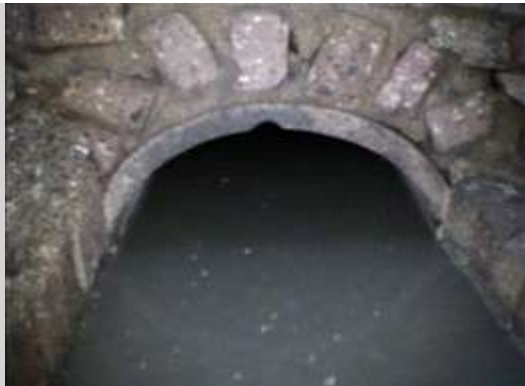
9 O'Clock Inflow

12 in. Circular Gravity Sewer

Pipe In @ 9 O'Clock

Pipe Height: **15.6** (in.) Rod and Bar (Angled)

Infiltration: **None** Pipe Seal Cond: **Sound**
